Broken rivers

The impacts of European-financed
small hydropower plants
on pristine Balkan landscapes

December 2017

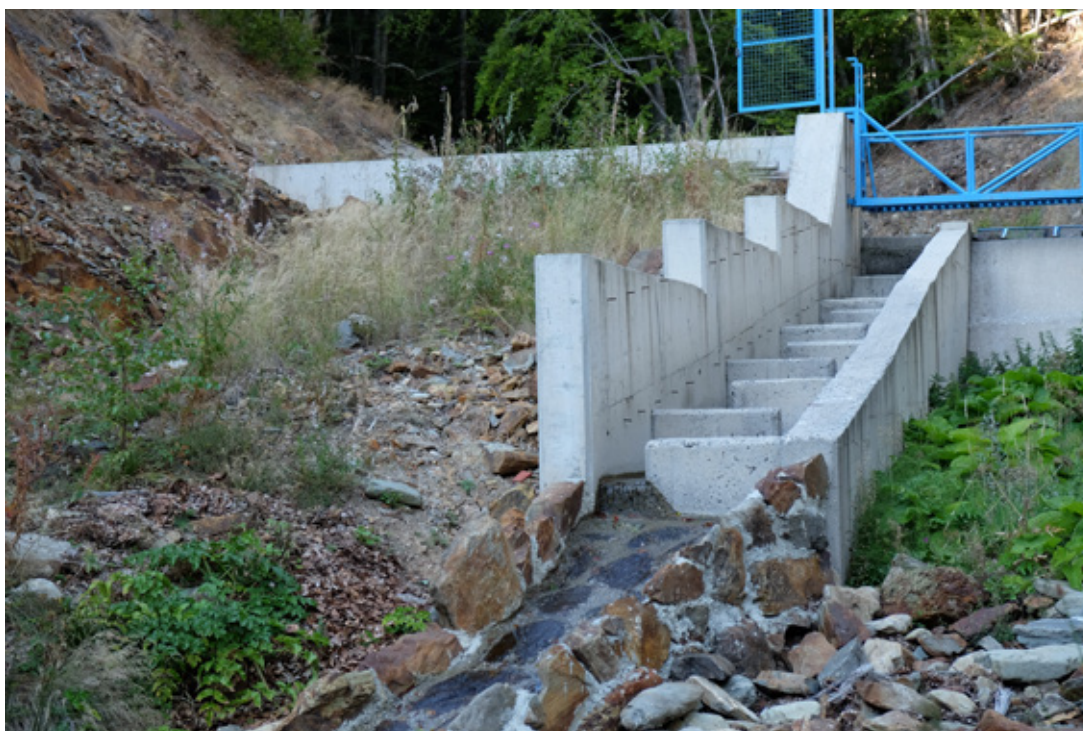
Figure 6: An almost dry fish pass at the Brajcinska reka 1 intake

Even if the residual flow was adequate, the biocorridor on both intakes is disrupted. On the Brajcinska river intake,¹²⁶ close examination shows the fish pass upstream entrance is inadequate, while the upstream exit is blocked. Although the fish pass dimensions are mostly within the recommended limits, except for the depth, there is no bottom substrate in the pools. On the Kriva Kobila river intake,¹²⁷ the fish pass upstream entrance is inappropriate, and the upstream exit is again blocked. The fish pass dimensions are in line with the most commonly used guidelines. Bottom substrate is present in the pools.

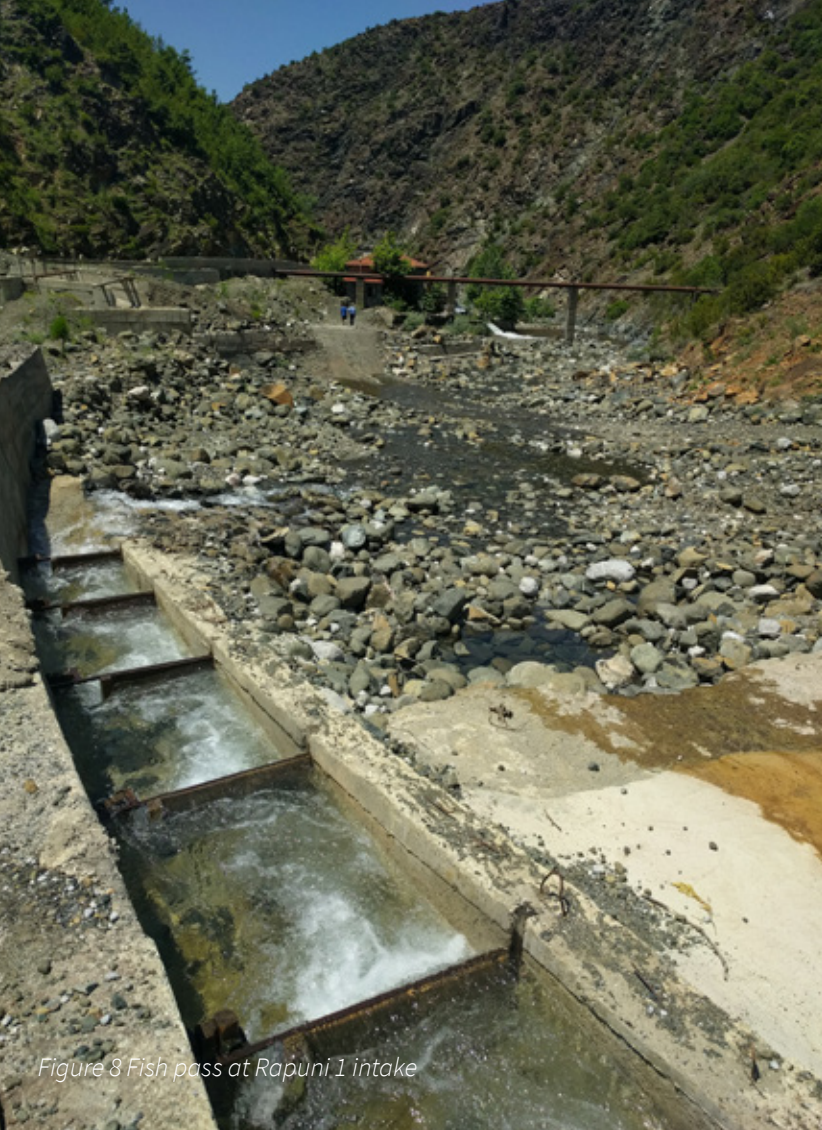
Figure 8 Fish pass at Rapuni 1 intake

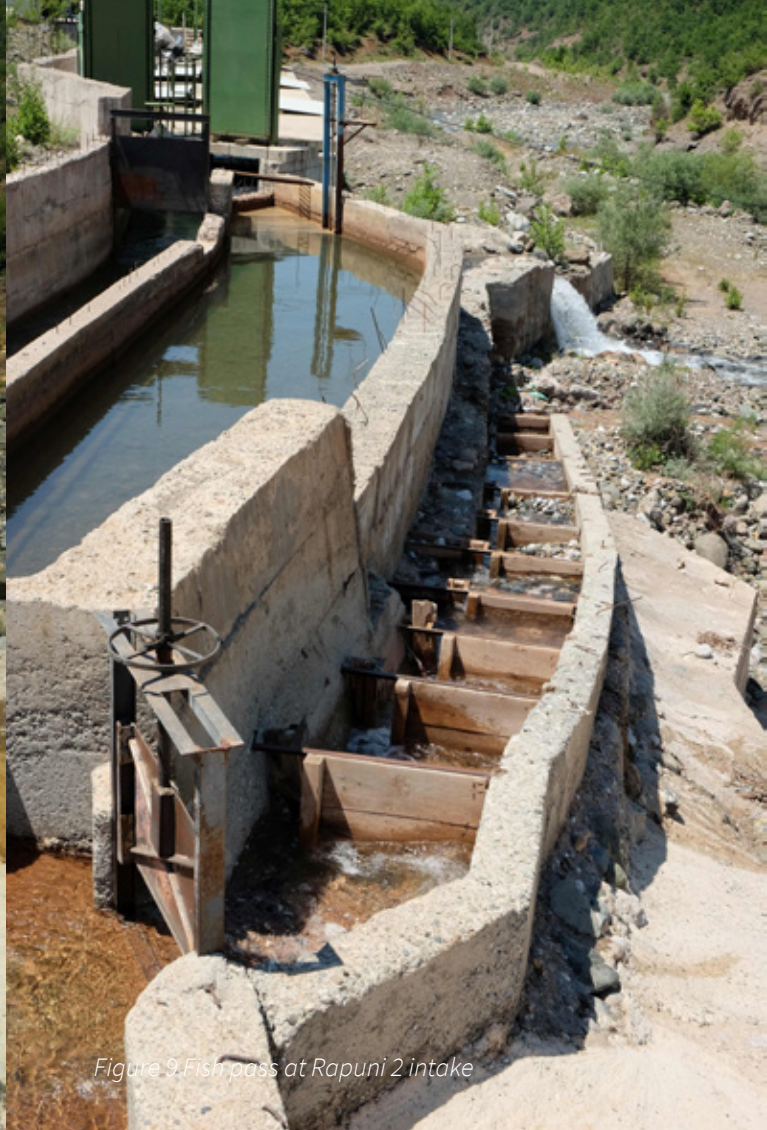
The fish pass constructed on the intake of Rapuni 2 lacks water and has an almost dry downstream entrance and a water gate at the upstream exit in a halfway down position. Also, at the time of the visit a more attractive flow compared to the tailwater released from the fish pass was discharged further below. The Rapuni 1 fish pass is better designed, and has more water. But given the deficient residual flow regime, the fish passes are useless, and would only to have some effect if there was more water below the intakes.

Figure 9 Fish pass at Rapuni 2 intake

- Immediately ensure provisional residual flow of 300 l/s. Carry out research to establish a proper environmental flow that will be sufficient to sustain all ecological functions.
- Compensate the miller for the losses so far.
- Establish a link with the Regional Directorate for Protected Areas to coordinate mitigation and restoration measures in a manner that will not be detrimental to the ecological integrity of the National Park (e.g. not using invasive species for restoration measures).
- Commission research on the functionality of the fish-passes on the Rapuni 1 & 2 intakes and take measures to improve them.
- EIA should be obligatory even for smaller projects, in particular in biodiversity rich and protected areas.

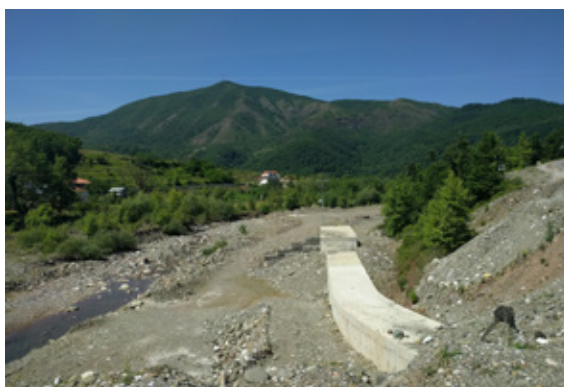
Figure 10: Tunnel taking tailwater to Rapuni 3 & 4

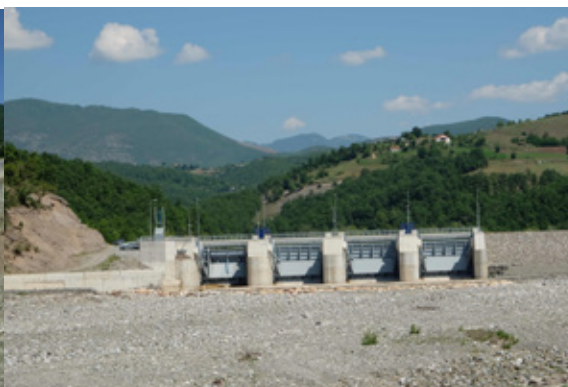
It is worth noting that the Rapuni 3 & 4 project, that operates illegally by not releasing residual flow into the river bed, although not financed by the EBRD, is financed by the National Bank of Greece (NBG),⁶⁴ the bank owned by the Hellenic Financial Stability Fund. Apart from breaching ecological flow standards, the project has damaged the houses in the village of Togež without proper compensation.⁶⁵ It is also on the boundary of the Kukurman natural reserve, a nominated Emerald site.

Figure 11: Rapuni 3 & 4 dam leaves no residual flow

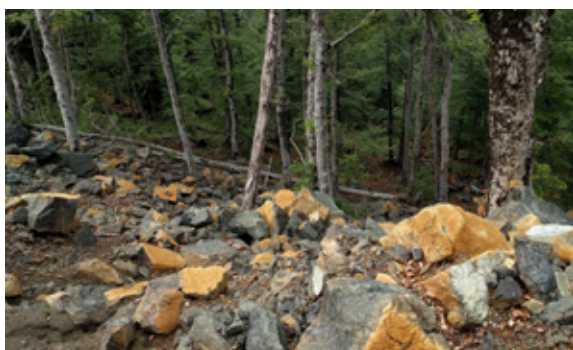
Deforestation has resulted from the excavation work carried out to make space for the penstock. The excavation for the pipeline foundations, access roads and electricity lines also removed tree and vegetation cover. The company was fined several times for cutting trees without permission.⁷⁹ The status of these infringements is not clear, and there was no feedback to the Bulqizë office of the State Inspectorate of Environment and Forestry about the status of the fine.⁸⁰ The area is known for its pristine beech forests⁸¹ that sustain a population of brown bears⁸² as well as different endemic plant species.⁸³

Figure 14: Excavated rocks discarded in the woods

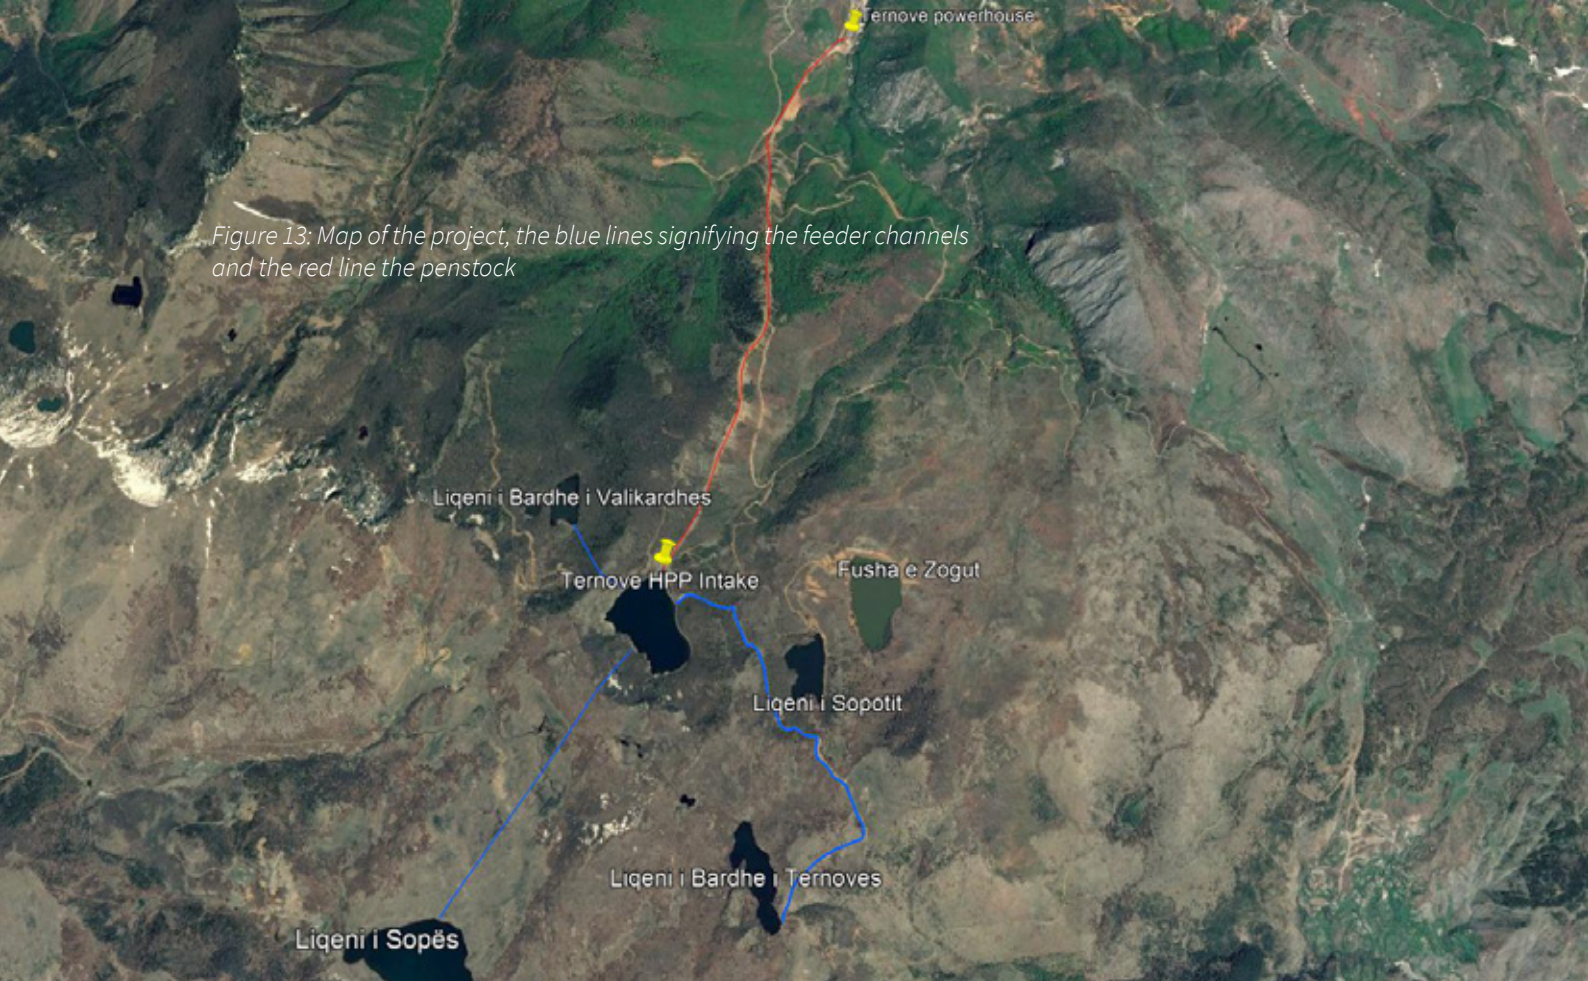
Figure 13: Map of the project, the blue lines signifying the feeder channels and the red line the penstock

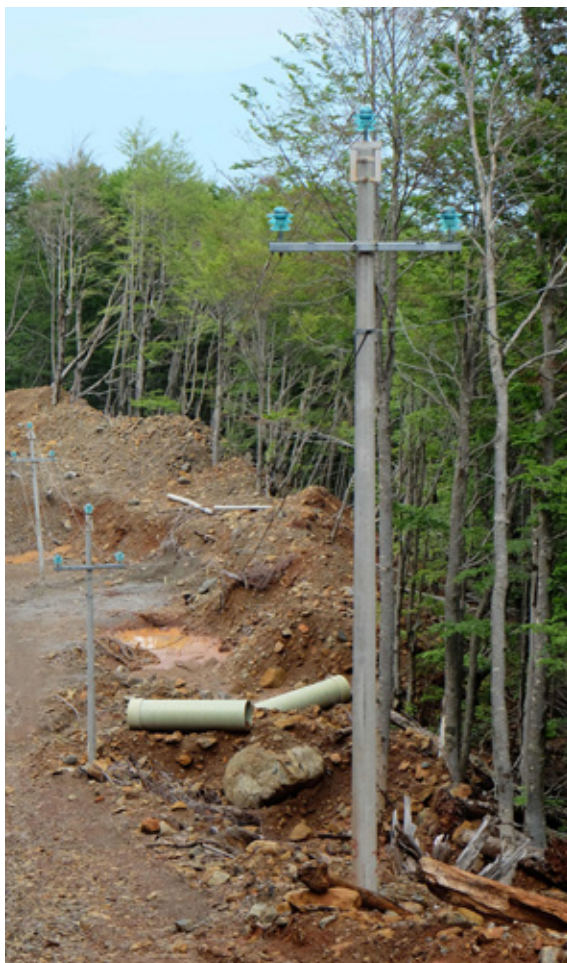
Figure 16: A section cleared for the access road and electricity poles

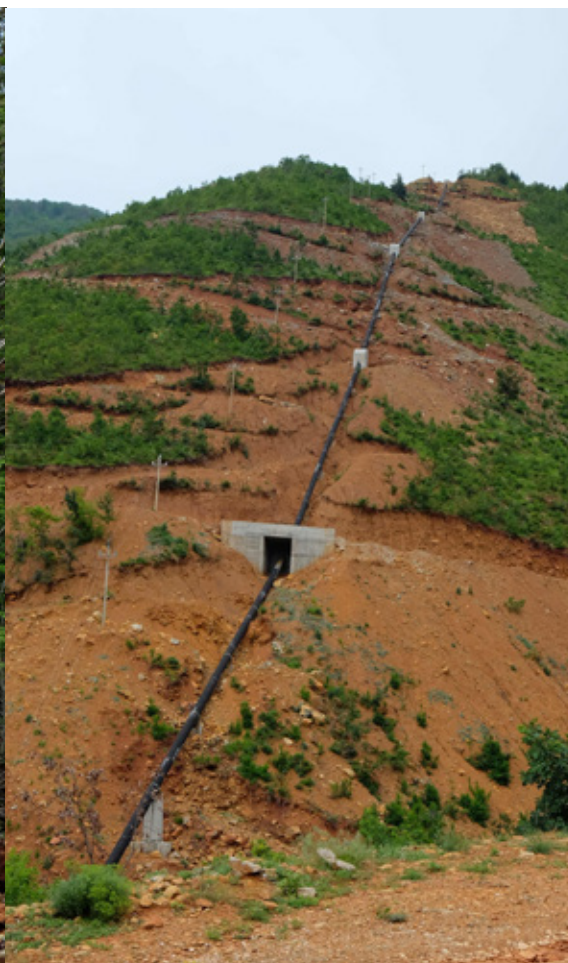
ground and is surrounded by eroded hillsides, mainly consisting of clay soil. The central section of the pipeline in particular is affected by erosion, to the extent that it seems there is a risk of landslides.

Figure 17: Erosion around the penstock

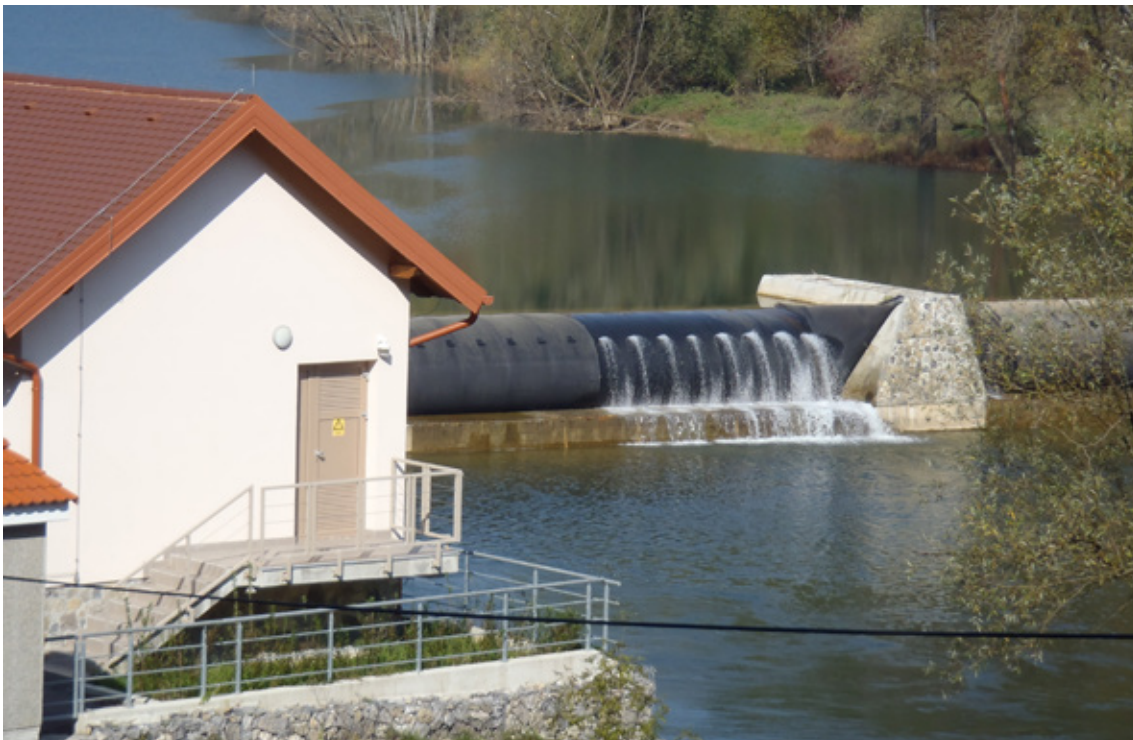
Ilovac hydropower plant, which is situated about 5 km upstream from the town of Ozalj, started operating in 2015. It is owned by Tekonet d.o.o., which otherwise deals with telecommunications systems.⁹⁷ The plant was built at the site of a pre-existing weir, which was presumably assumed to reduce its impact, however it was completely reconstructed and its height increased by more than two metres. A 35-metre section of the weir has been removed and replaced with a rubber dam 3.4 metres high in order to better control the water flow.⁹⁸ Water flows through the turbines and over the dam.

Figure 18: Ilovac dam, Croatia

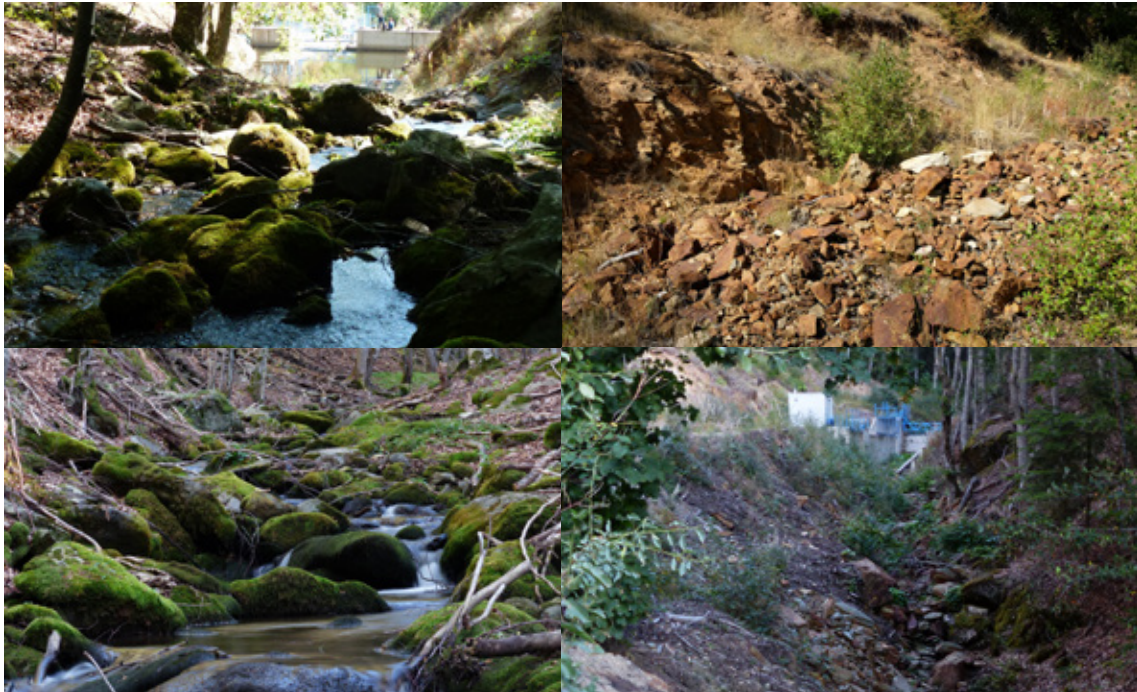
During the field visit in September 2017, in the dry season, the team documented a residual flow of only 0.001 m³/s (1 litre per second) on both intakes, which translates into a completely dry river bed within a few dozen metres from the intake on the Brajcinska river, and around 150 m from the intake on the Kriva Kobila river. The residual flow set by the water permit is 0.0201 m³/s for Kriva Kobila, while for the intake on Brajcinska it is 0.0355 m³/s.¹²⁴ All the aquatic life in an estimated stretch of 1.5 km of Brajcinska and Kriva Kobila rivers has been destroyed. After a few hundred metres from the former confluence with the Kriva Kobila, the Brajcinska river starts to recover, most probably because of the streams that join the main waterway from the sides of the valley. Yet the hydropower plant is featured in an EBRD promotional YouTube video as an example of a “green investment”.¹²⁵

The field visit uncovered the illegal practice of not releasing residual flow from the intakes at both Kriva Kobila and Brajcinska river. Critical habitat of Prespa trout has been degraded.

Figure 20: Images clockwise from top left: pristine river above the intake on Kriva Kobila; dry river bed below the intake on Kriva Kobila; dry river below the intake on Brajcinska; pristine river above the intake on Brajcinska

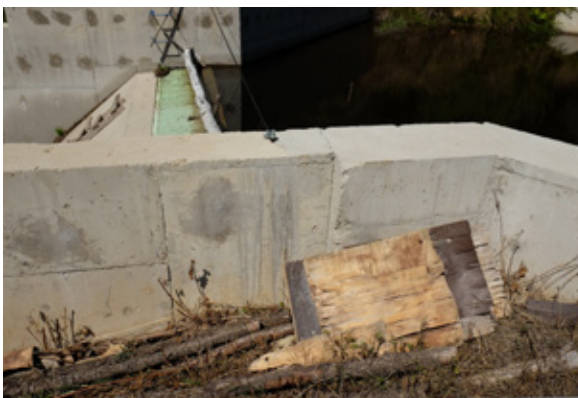
Figure 22: An appliance potentially used for blocking the fish pass on Stanisar intake

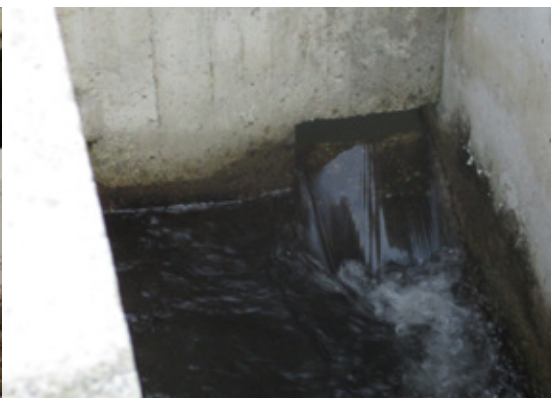
Figure 23: The upstream exit from the fish pass on Brajcinska intake

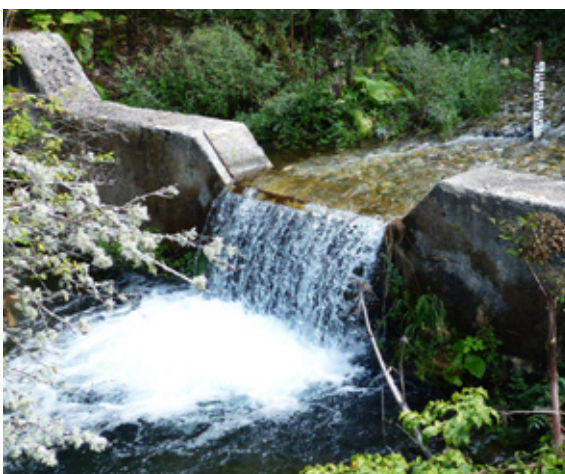
Figure 26: The weir above the powerhouse September 2017

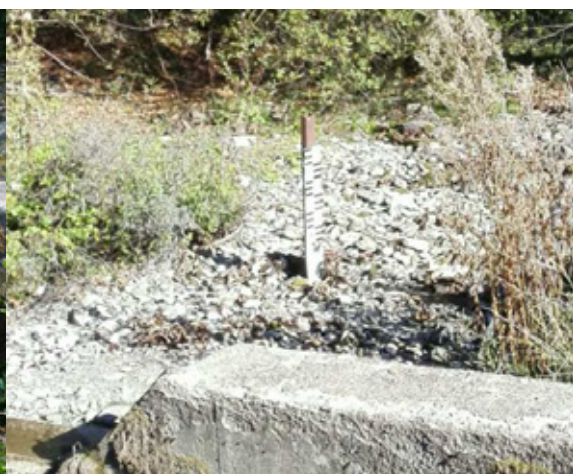
Figure 27: The weir above the powerhouse November 2017

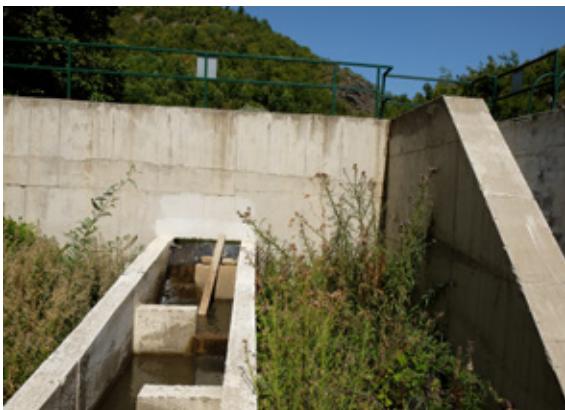
Figure 29: Blocked fish pass

- Ensure that blocking of the fish passes does not occur, via ensuring constant video monitoring

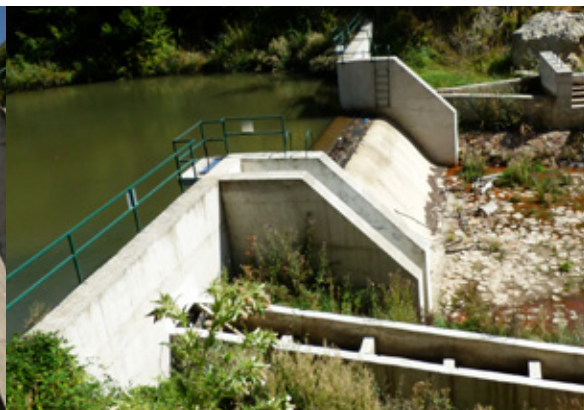
Figure 30: The intake and the pond

- Rehabilitate the riparian vegetation and forests destroyed by building the new road
- Ensure regular biodiversity monitoring of the Priority Species present in the area
- Clean up the pool created by the intake

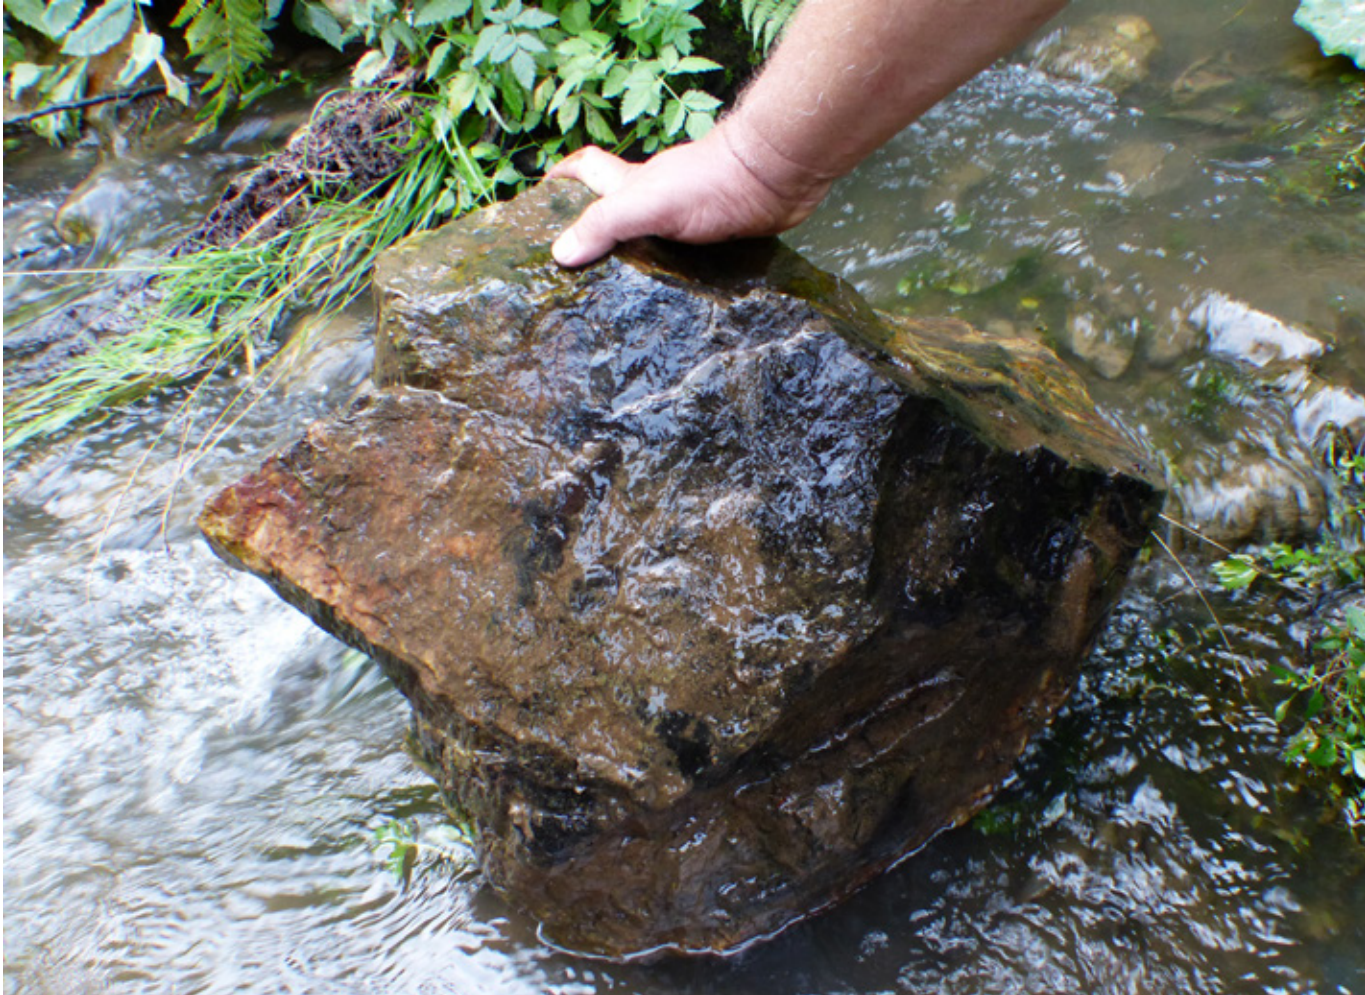
There are excessive algae communities and the stones are black from poor water quality or lack of water. Our biological assessment showed that the density of macroinvertebrates and the number of sensitive taxa moderately decreased, confirming less favourable conditions.¹⁶²

Figure 31: Rocks below the intake

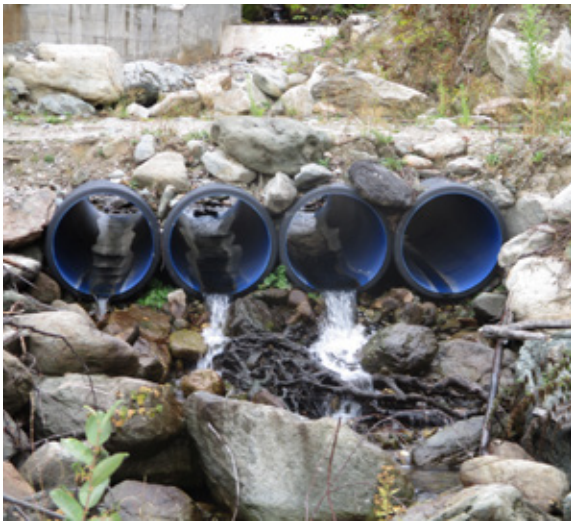
Figure 35: Culvert

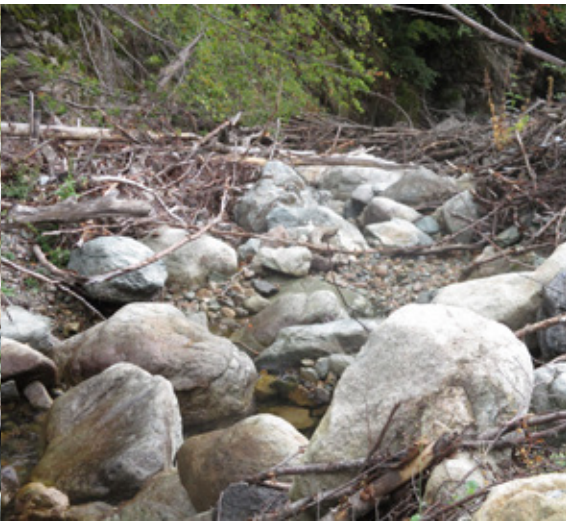
During the construction of the road to the intake and the excavation for the pipeline, the materials were dumped in the riverbed, as evidenced on the image above. On the side of the road, there were excessive stretches of the woods cut, almost clearcuts, and in some sections erosion on the hillsides. The lower stretches of the Bistrica valley are covered with Chestnut (*Castanera sativa*) forest (Directive 42/43 habitat 9260) especially on the right bank of the river. Habitat 9170 (oak and hornbeam) is found in the middle sections of the river. Higher up beech forests are dominant with *Taxus baccata*. In some steep areas Priority Habitat 9180 was found at the river edge.

Figure 36: Riverbed filled with branches and excavated materials
